Triennial Inspection Report of the Low Voltage Installation

at University Hospital Llandough

**for Cardiff & Vale
University Health Board**

Date: June 2022

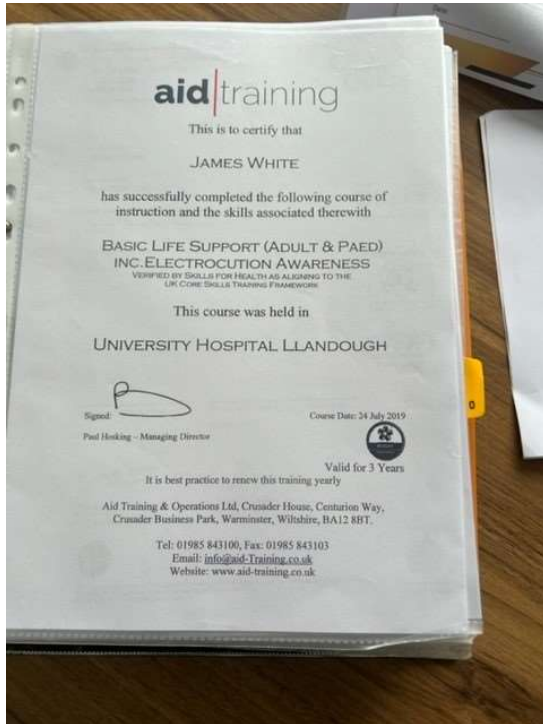
Yes. Both Chris Watts & Peter Cox 1 st aid training expires on 24 th July 2022

Figure 9: CP 1st Aid Certificate expires July 2022

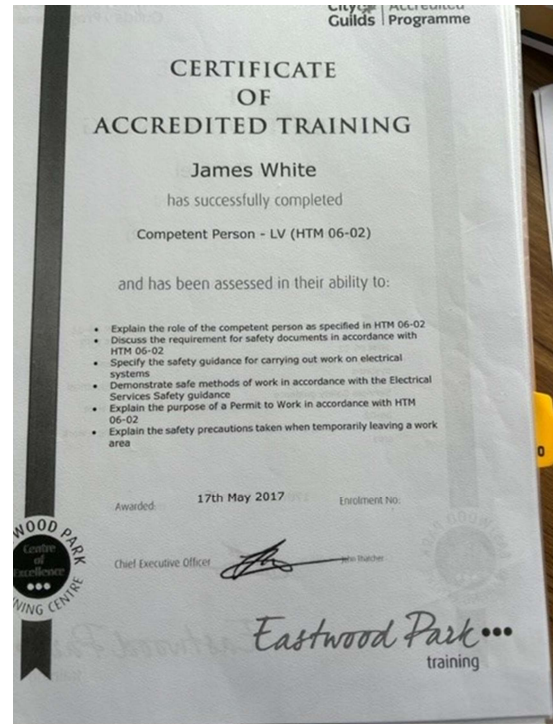
3.3.14	Is the register of competent persons up to date	 		<i>No, many CP appointments have expired.</i>
3.3.15	Is all of the distribution system included in the planned maintenance programme?

Figure 10: CP (LV) Certificate expired May 2020

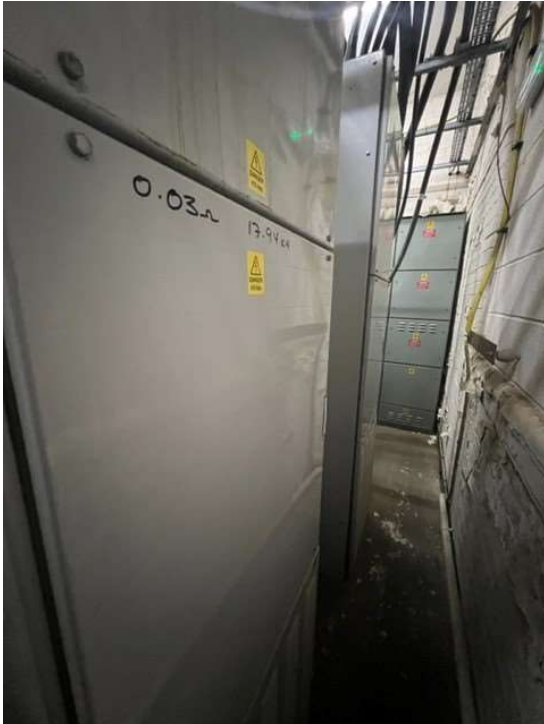
**Figure 20: LV 1 Switchboard, not fully WHTM06-01 compliant**

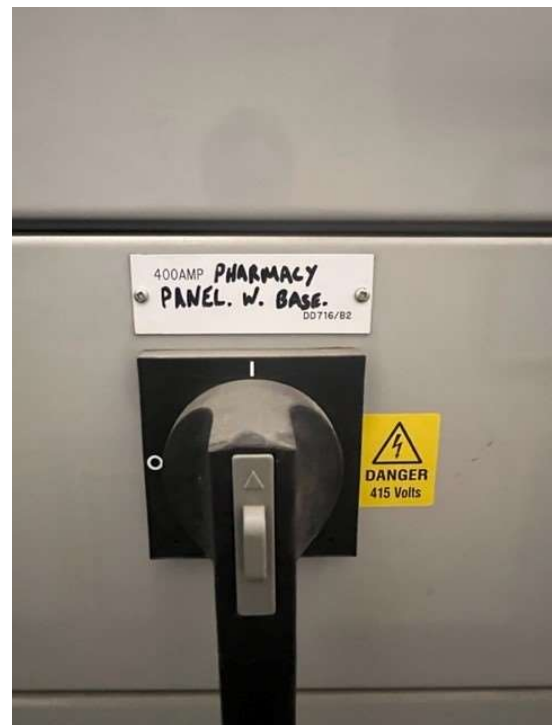
<i>Suitable permanent labels identifying the circuit need to be installed for some circuits to replace handwritten or dyno tape labels. Circuits may need to be checked for accuracy.</i>

Figure 23: Handwritten labelling

- 4.13 Suitable permanent labels identifying the circuit need to be installed for some circuits to replace handwritten or dyno tape labels. Circuits may need to be checked for accuracy.

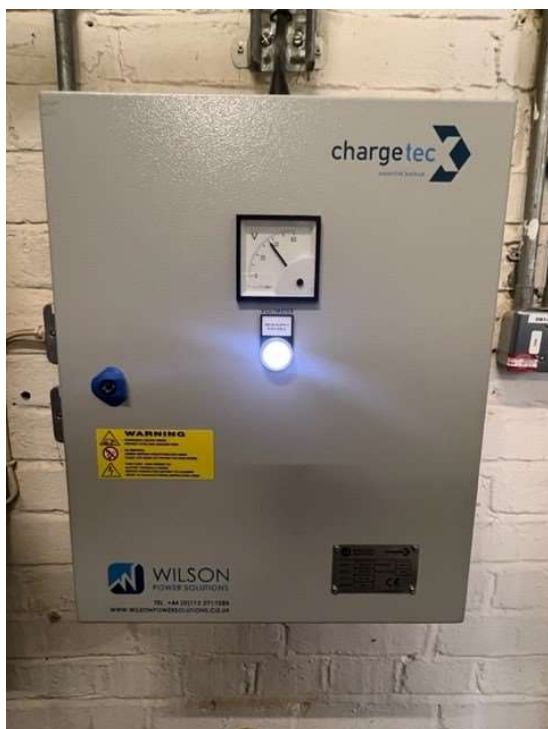
<i>Yes, there was evidence that the PFC was serviced October 2021, however the unit located within Substation 1 has been taken out of service.</i>

Figure 26: Power Factor Correction Unit switched off

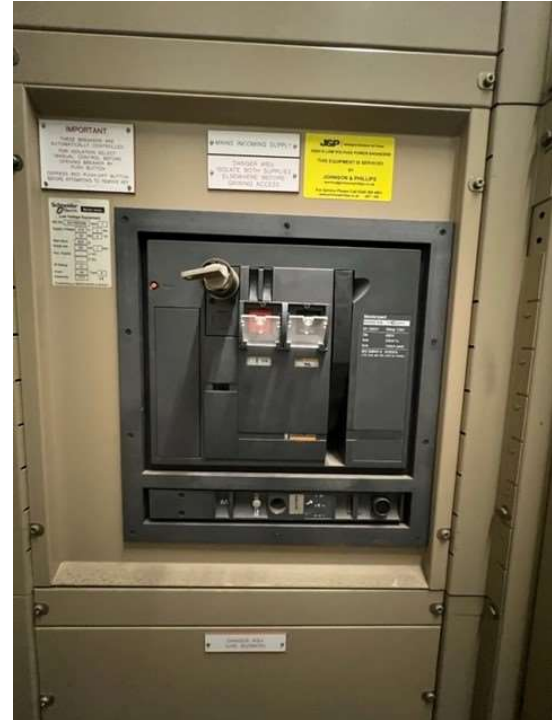
- 3.3.3 Some LV switchgear is out of production, and spares and technical information may no longer be available. This could put the hospital at risk if failure of components were to occur.

Figure 33: LV 2 Switchboard, now obsolete & not WHTM06-01 compliant

- 4.9 Up-to-date schematics should be produced and fixed on the wall in all switchrooms.
- 4.10 Some LV switchgear is out of production due to its age, and spares and technical information may no longer be available. This would put the hospital at risk if failure of components were to occur. Consideration should be given for its replacement in the near future.

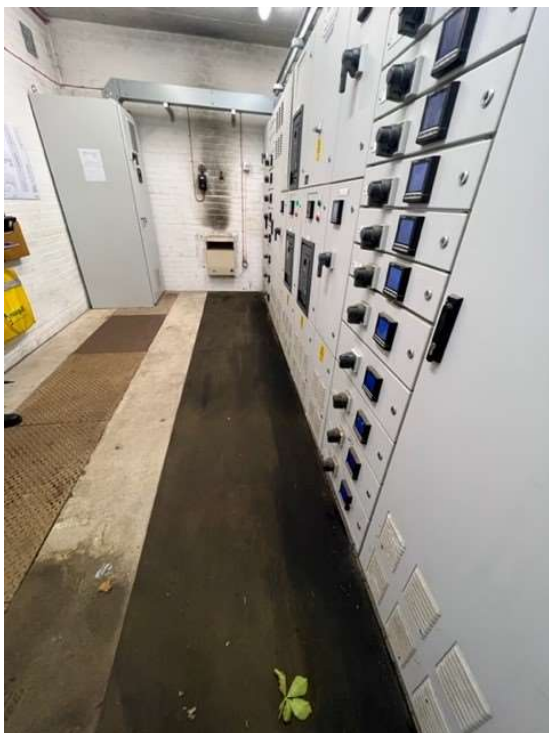
Figure 40: LV 5 Switchboard, not fully WHTM06-01 compliant

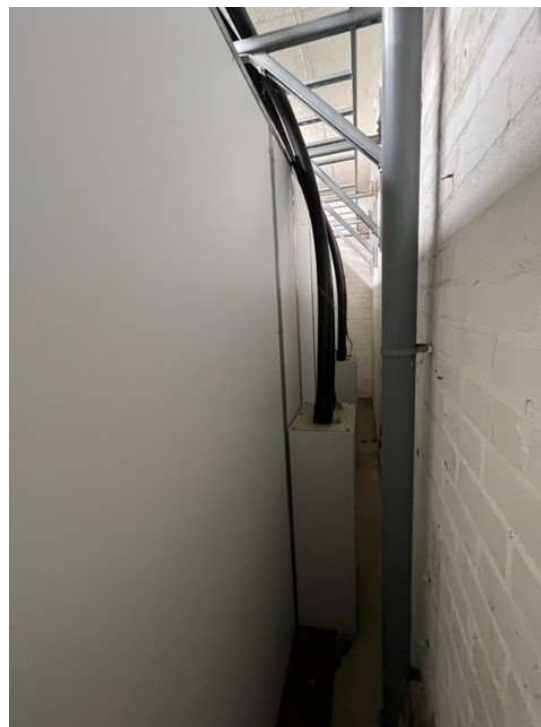
Figure 41: No rubber insulated mat installed in front of PFC Unit

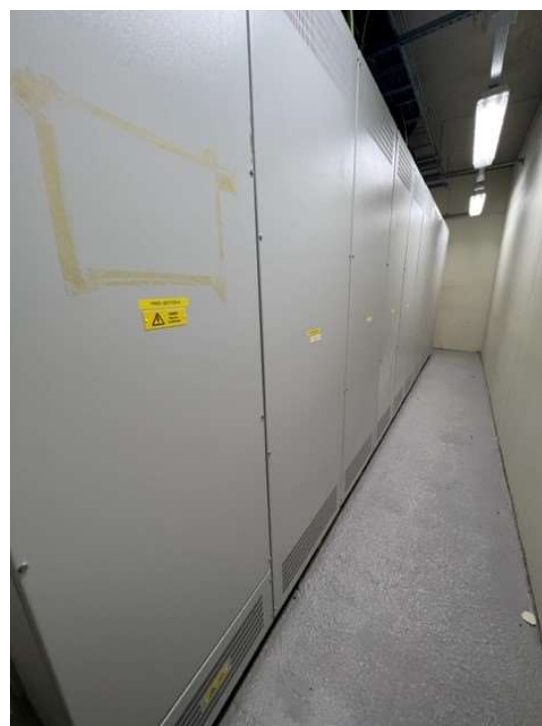
Figure 51: LV E Switchboard, not fully WHTM06-01 compliant.

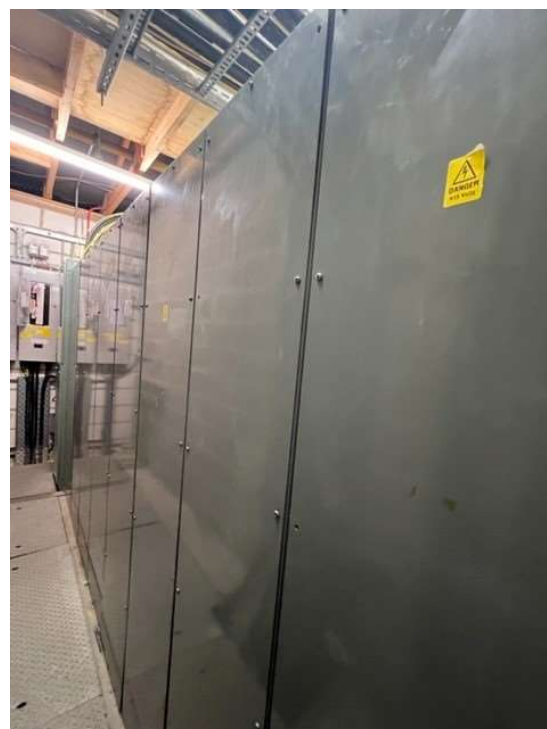
Figure 59: LV 20 Switchboard, now obsolete & not WHTM06-01 compliant
